Bulletin: Low Roof (Option Code FA 1)

09/08/2015

FA 1 - Information

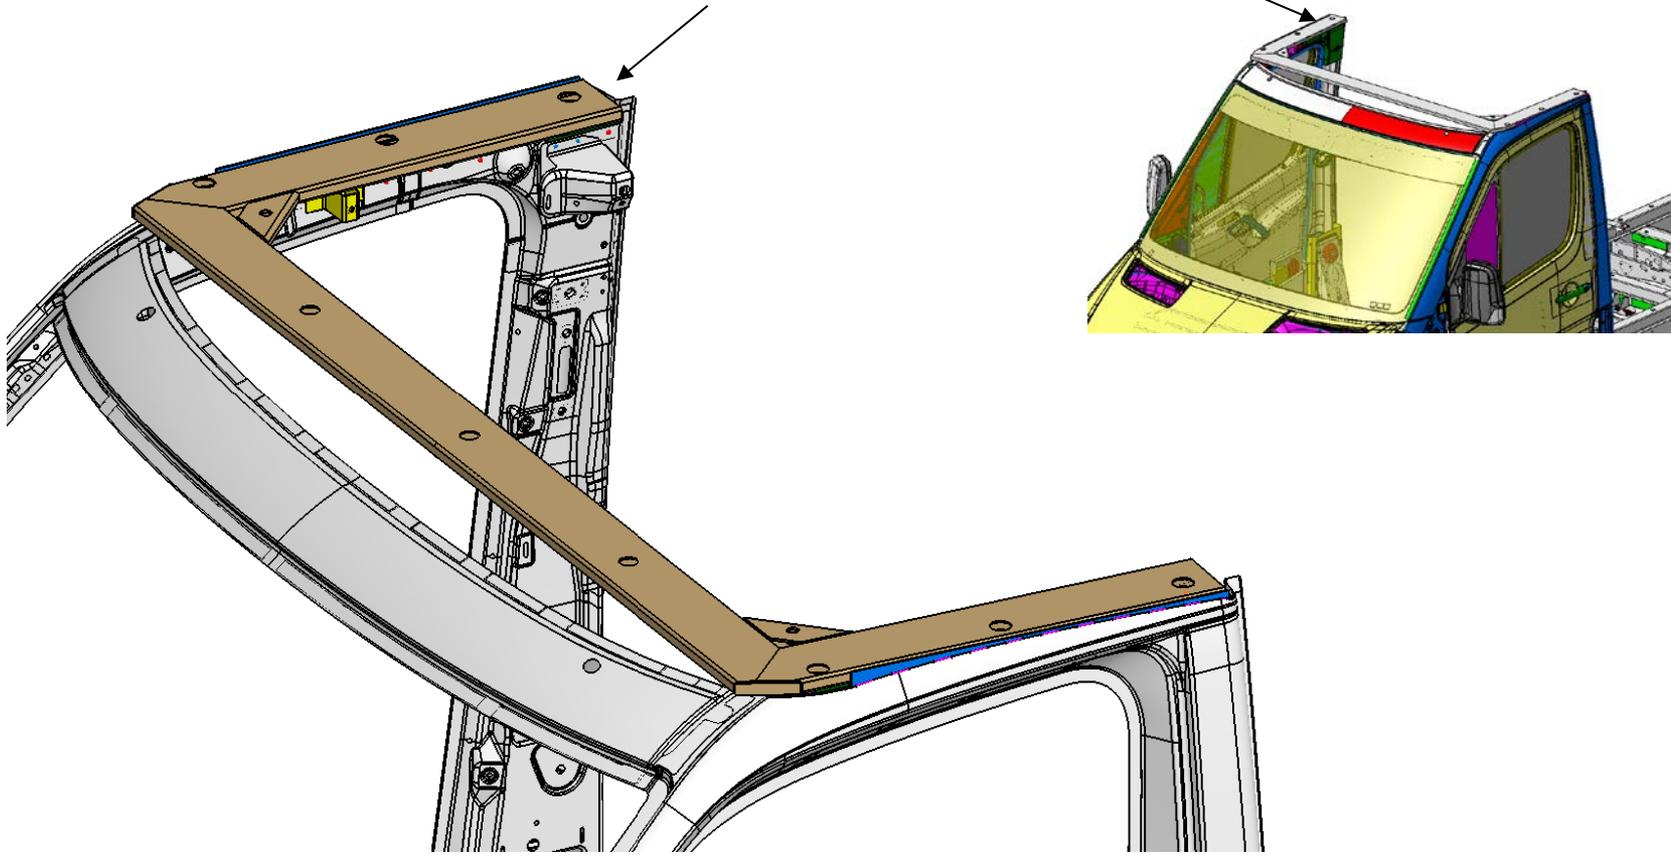
Reinforcement frame to compensate for structural integrity

Top of frame at Z=1595mm
(86mm - 3.4in lower than original roof level)

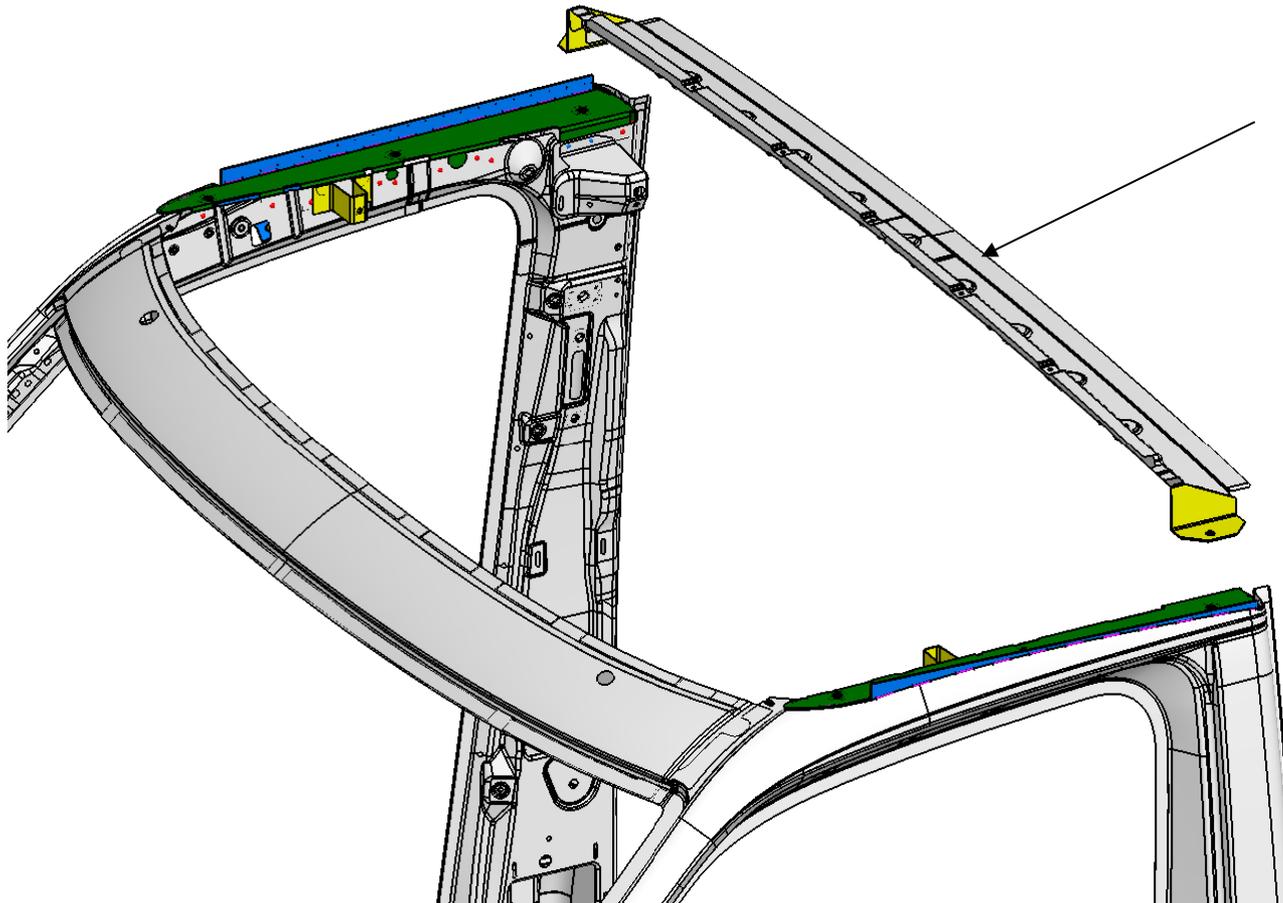
Roof-bow removal (Upfitter)

Remove roof-bow

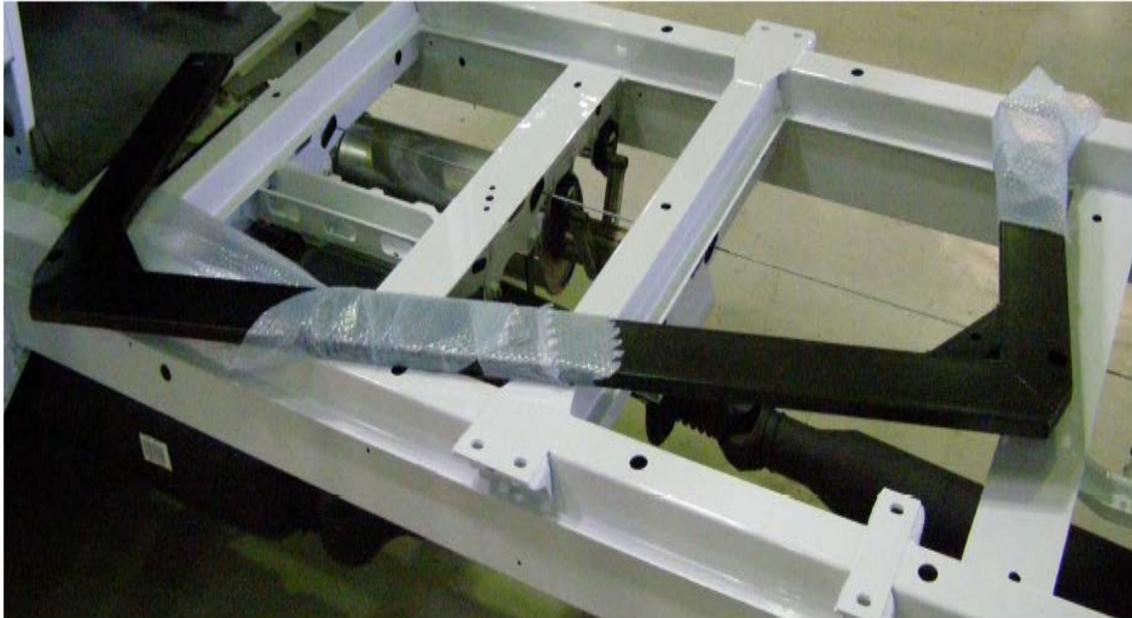
Scope of delivery:

- Roof-bow bolted for shipping

Reinforcement frame to compensate for structural integrity

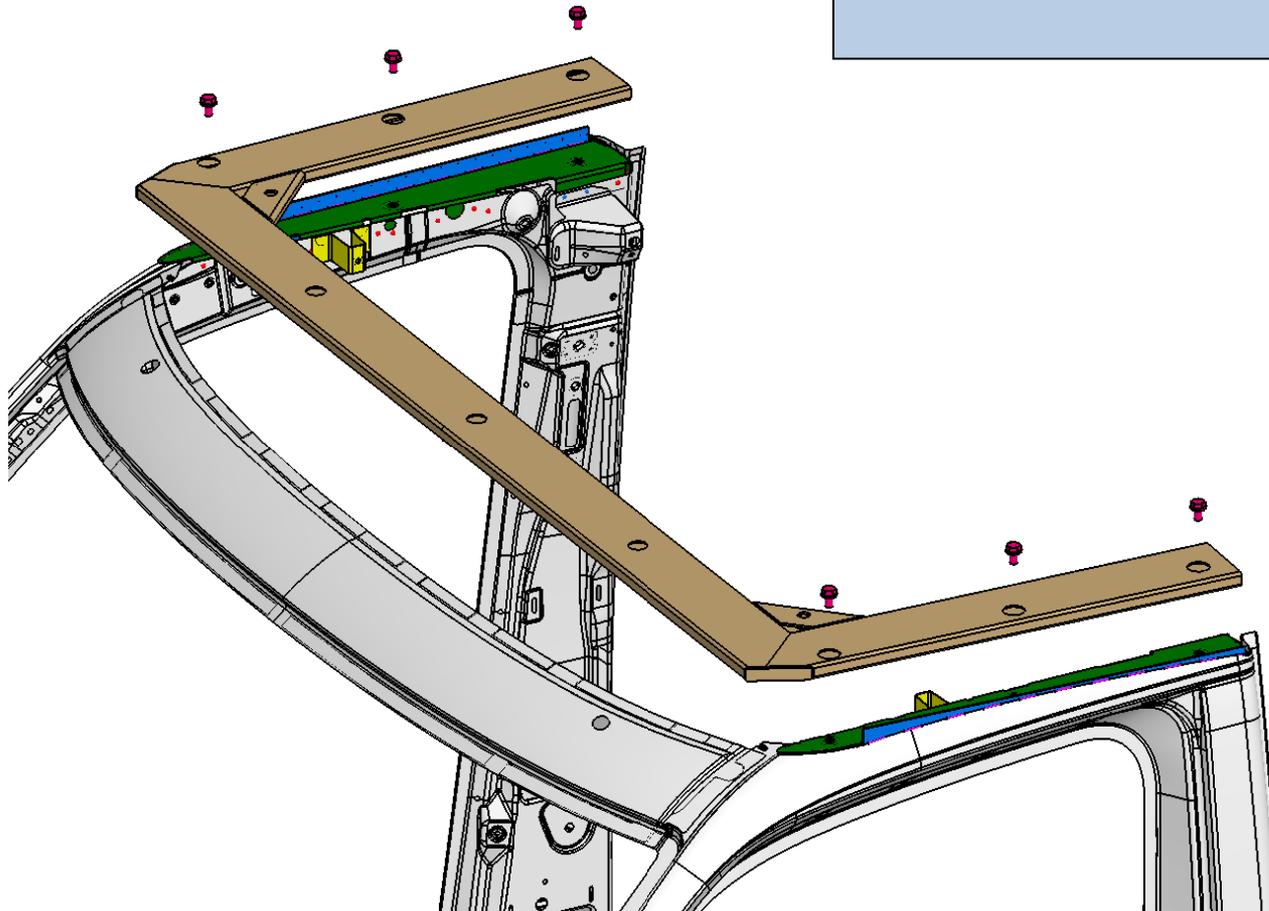
Part # N000000 004306 Hex Bolts MBN 10143-M10X 20-10.9-MK DBL9460.40 Qty 6

Torque: 40Nm +/- 2Nm → 29.5ftlb +/- 1.5ftlb

Bolting reinforcement frame (Upfitter)
